**From:** Todd Kirrane  
**Sent:** Tuesday, November 27, 2018 4:24 PM  
**To:** Maria Morelli  
**Cc:** Peter Ditto; Daniel Martin; Alison Steinfeld  
**Subject:** 1299 Beacon: Followup Traffic Impact Comments

Longwood Avenue at Sewall Avenue  
Proposed Intersection Improvements

*A study performed by the Brookline Pedestrian Advisory Committee*

## Bicycle and Pedestrian Infrastructure Assessments Brookline, MA

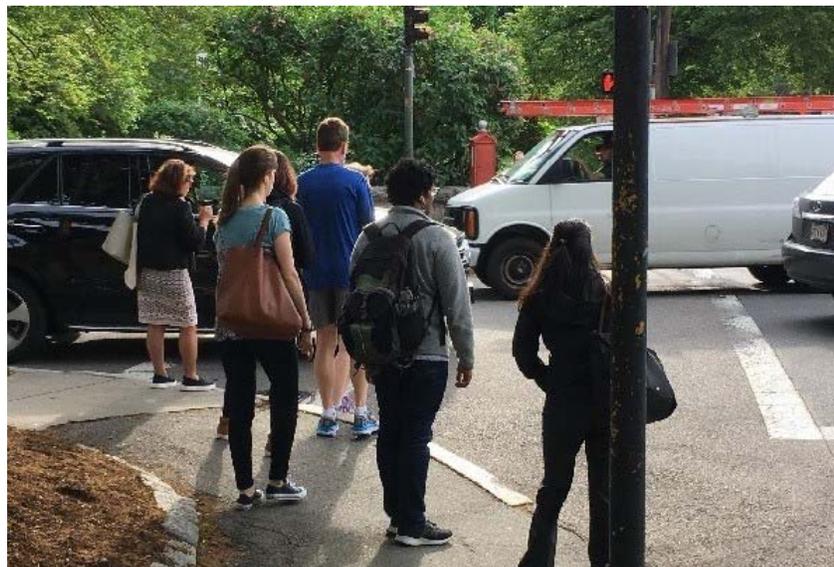
- H. The intersection of Kent and Longwood deserves a professional engineering study because of congestion associated with a very high volume of automobile, bicycle, and pedestrian traffic. Especially during the morning rush, this intersection is important because it serves many pedestrians traveling to the Longwood Medical area -- it was the busiest intersection we observed in terms of foot traffic. There are multiple issues:

*Above photo shows Longwood & Kent during morning rush.  
Note the narrow staging area.*

- The Transportation Board should request a professional engineering study of the Kent & Longwood intersection. Goals should include steps that could be taken to mitigate the risks caused by congestion and pedestrian-bicycle-vehicle conflicts, expanded pedestrian staging areas, and up-to-standard handicap ramps that provide direct entry into crosswalks. [Note that the one specific warning sign for pedestrians recommended earlier in this report could be implemented near-term without waiting for this engineering study.]

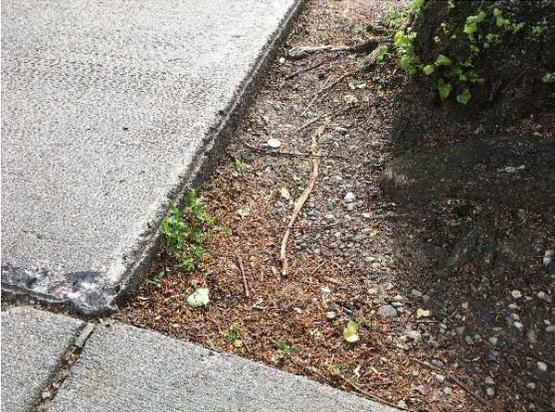
Excessive drop-off at edge of tree well, Longwood near Chapel

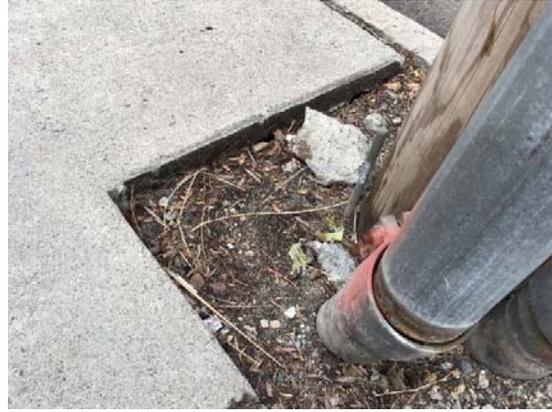
Excessive drop-off at utility well, Longwood Ave near Sewall – see safer approach below

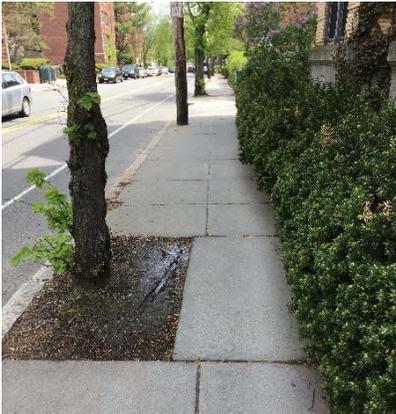
Hedge encroaching on sidewalk, pathway by tree well too narrow, Longwood near Marshall

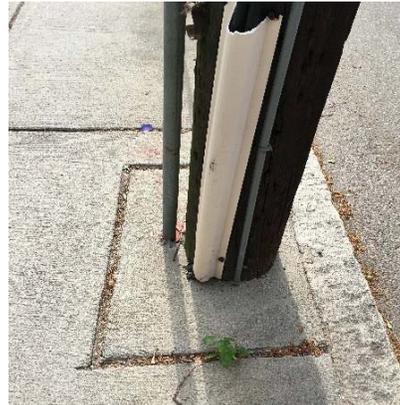
Utility well filled in with concrete, Longwood near Chapel

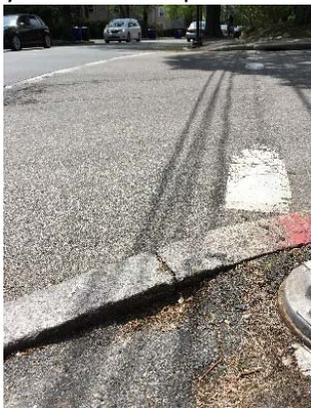
NE corner of Kent & Longwood, sunken pavement by curb could trip someone

NE corner, sidewalk is sunk next to curb, creating a tripping hazard; needs to be filled

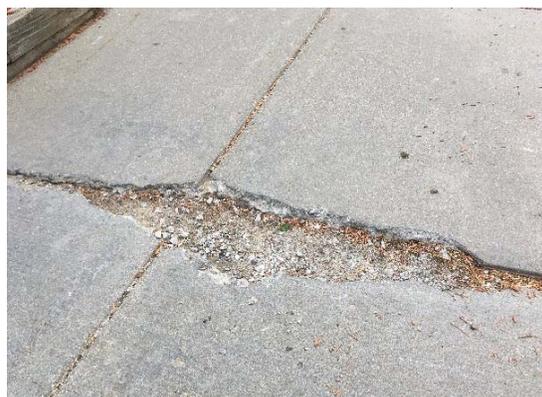
Near 102 Longwood Ave, broken pavement

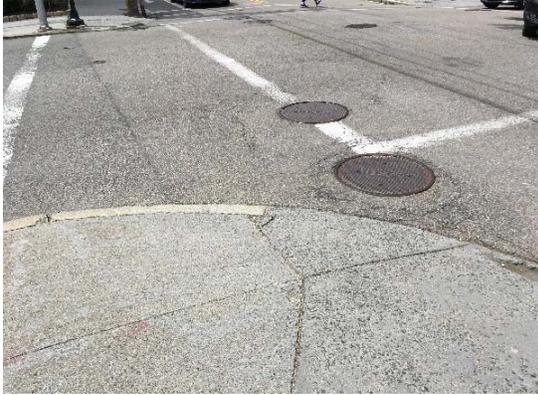
St Paul & Longwood, no detectable pavement, crosswalk leads to pole & curb across street

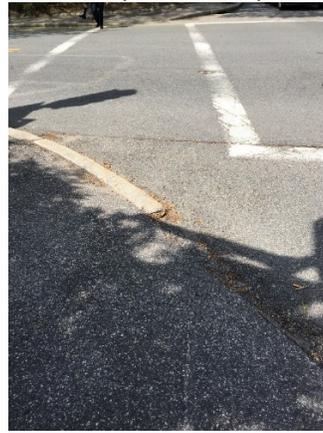
Kent & Longwood, makeshift partial handicap ramp, no detectable pavement, paint fading

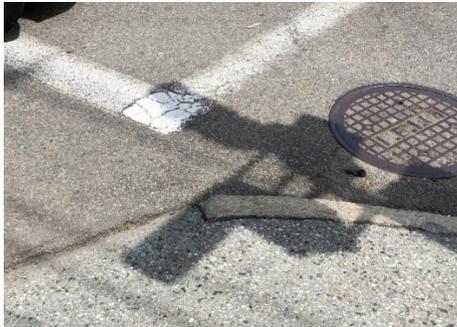
Longwood & St Paul, no detectable pavement on makeshift ramp, ramp doesn't readily lead to both crosswalks

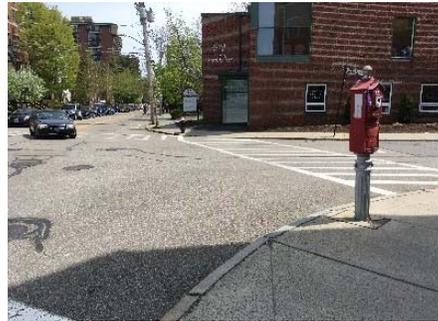
Longwood & Sewall – E-W crosswalk not aligned w/ pedestrian path

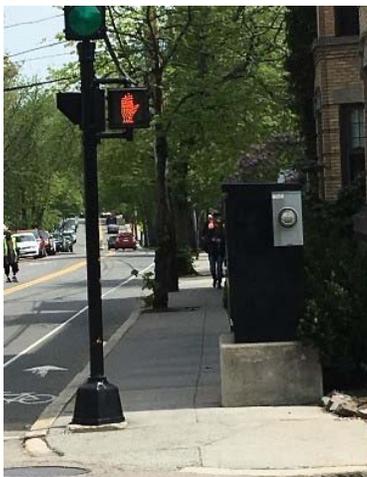
Large utility box & pole narrow sidewalk, Longwood & St Paul

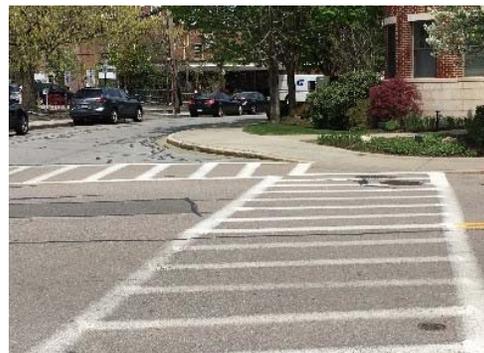
Longwood & Sewall – wide radius NE corner, crosswalk not well aligned w/ N-S ped travel

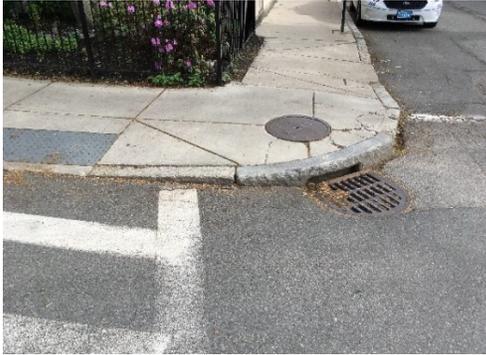
- L. The existence of storm drain grates at multiple corners along Longwood (e.g., at Marshall and at Kent) prevents handicap ramps from being placed in the most sensible and accessible locations. Often this is the cause of crosswalks not being properly aligned with sidewalks. Some rethinking of how best to resolve these competing needs is required.

Storm drain at NW corner Longwood & Marshall forces crosswalk and ramp to the left

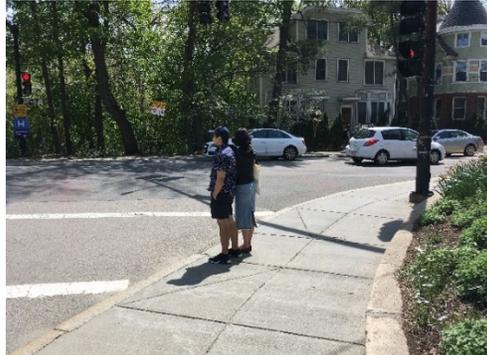
Longwood & Chapel – no crosswalk on west side of intersection

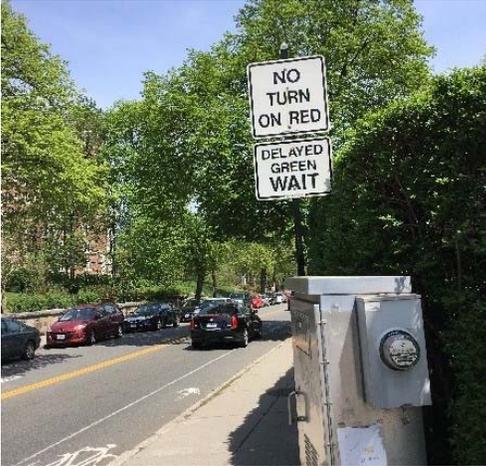
Longwood & Kent – we warn drivers to wait for delayed green, we should warn pedestrians to wait for delayed walk

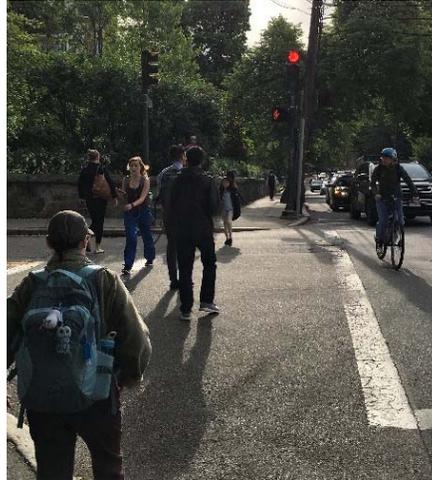
Longwood-Kent – westbound traffic has green, peds should wait for delayed green but many don't

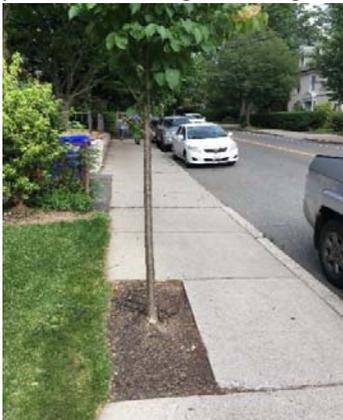
150 Longwood, oddly placed tree on property side of sidewalk. Unexpected hazard for the visually impaired when it grows larger?

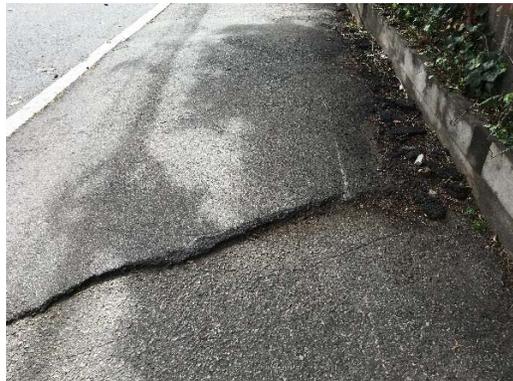
Broken asphalt sidewalk mid-way between 150 Longwood and Kent

From 156 Longwood to Kent - asphalt sidewalk has unexpected (hard to see) ups and down, probably heaved by former street or private trees. **Sidewalk broken in one spot, a tripping danger.**
