**Edward Devotion School**  
**MSBA**  
**Preliminary Design Program**

Brookline, Massachusetts

**Volume 4 of 5**

## Edward Devotion School Concept Study

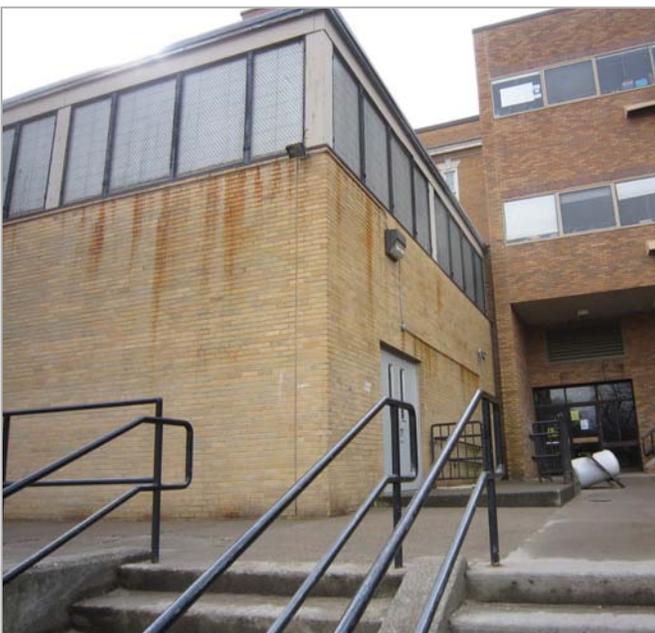
The exterior of the gymnasium is showing significant signs of rust. Because this can indicate possible deterioration in the window system, the flashing and drip edges of the system would need to be evaluated for replacement.

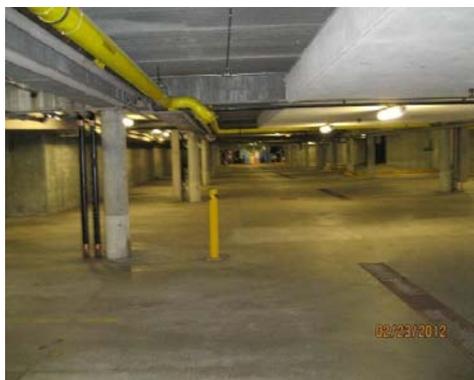
A (6") six inch 2 PSI high pressure gas line enters the parking garage level adjacent to the water service room. The 6" line runs horizontally along the foundation wall approximately 15 feet within an area enclosed and secured by chain link fencing. From this 6" service are two tee connections that drop

down to the floor and connect the gas service to a gas booster. The gas service has an inline full size bypass. The gas service at the bypass is labeled "Gas Booster Discontinued 9-17-10" indicating that the bypass valve is open and that the gas booster is offline. The school janitor indicated that the booster is still fully functional and used as a back up in the event that the gas pressure in the main line drops below acceptable levels for the proper operation of the Schools gas fired equipment. (boilers, water heaters etc). The 6" high pressure gas line then runs horizontally out of the secured fence along the underside of the garage ceiling to supply the existing gas fired equipment within the

school. The gas piping and booster pump appear to be in very good condition. The existing gas service is adequate to supply the current requirements of the school.

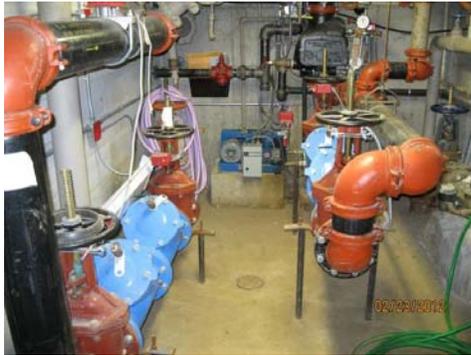
Located within the water service room are two 6" fire protection services and one 4" domestic water service. Both fire protection services enter the water service room through the concrete floor slab and transition horizontally above the floor to separate floor-mounted double check valve assemblies. One

service is labeled 'Stand Pipe Supply' and appears to serve the school's wet fire protection system. This same piping extends to the original building and feeds the second dry alarm valve located in the main floor storage room. It has a double check valve assembly as well. We believe this system feeds the attic dry sprinkler system. The other fire protection service exits the double check valve assembly in the garage water service room and continues on to a dry alarm valve located within the water service room. The dry alarm valve appears to feed the dry sprinkler system located in the garage area. Both fire protection services,

double check valve assemblies and the single dry alarm valve in the water service room appear to be in good condition. The double check valve assembly and the single dry alarm valve in the storage room of the original building appear to be in good condition.
