Route 65 – Priorities

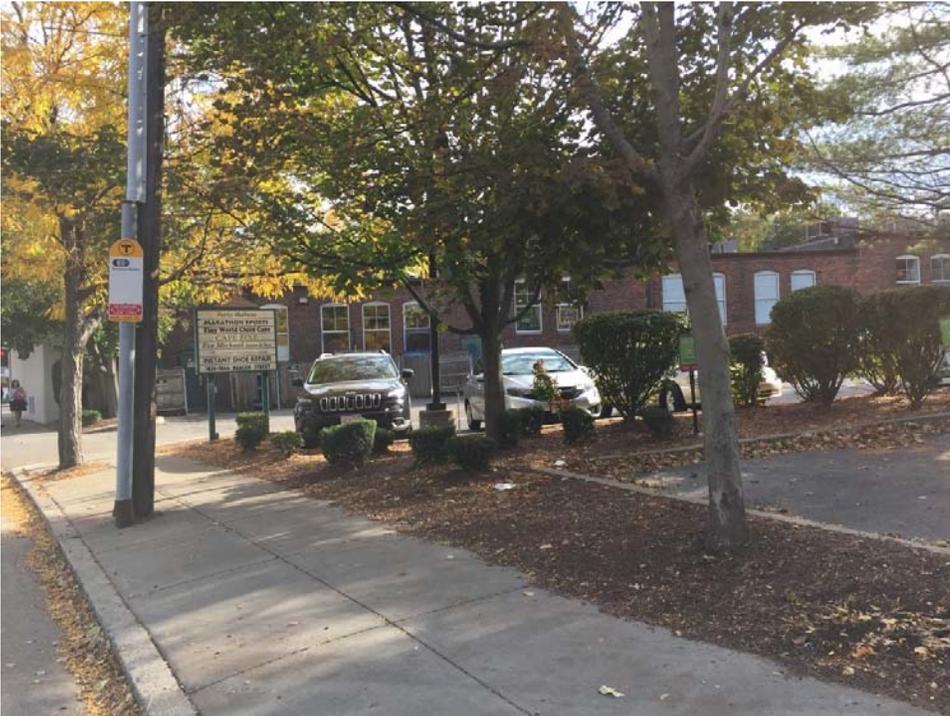
1276:

1276, Washington St @ Beacon St:

Average weekday boardings for this stop (28.6) should be combined with those for Stop 1277, 684 Washington St (42.6), for a total of 71.2. 1277 is located in front of a house & garage, and is blocked by metered parking. This may be the old location of 1276, but it is still in the MBTA database. 71.2 boardings automatically qualifies the stop for a shelter or bench, which could be situated in or near the planting strip between the sidewalk and the small parking lot. This stop may serve as a transfer point between the Route 65 and the C branch of the Green Line, enhancing eligibility.

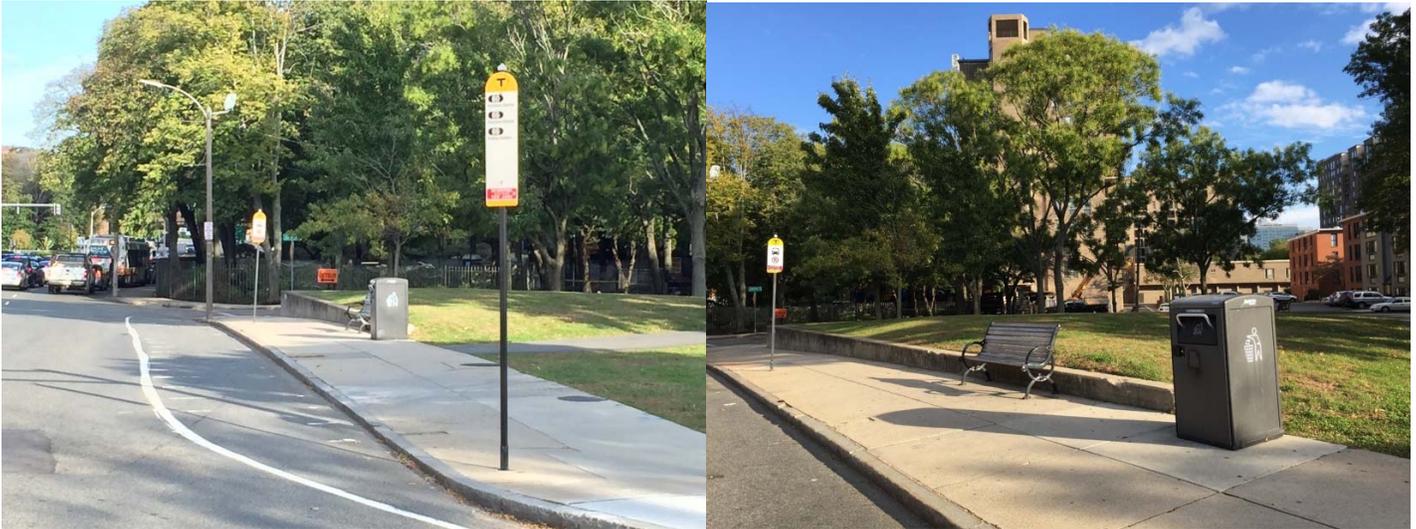
1555, Washington St @ Walnut:

This stop serves three bus routes, the 60, 65, and 66. Combined average weekday boardings total 148.9. Currently the location has only one bench; at least two are merited by MBTA guidelines. Due to the exposed location and proximity to public housing, two standard-size shelters, one large shelter, or (at minimum) one bench plus one standard-size shelter are recommended. Plenty of room is available on the sidewalk for these amenities, which should be chosen & installed in coordination with Gateway East project (100% design plans have been submitted to MassDOT).

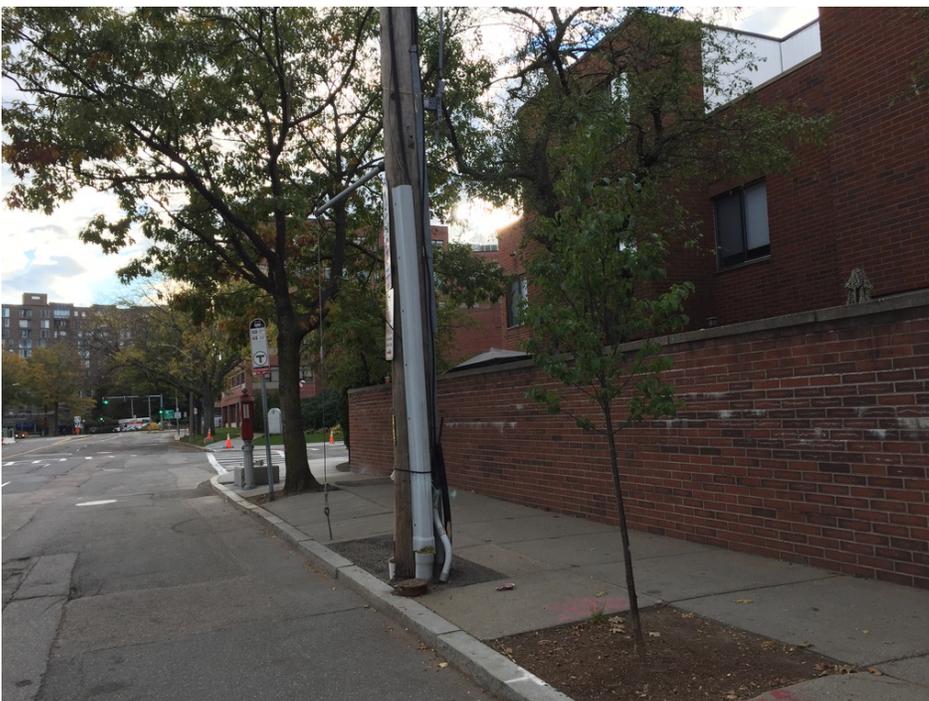
1525, Brookline Ave @ Pearl St:

This stop serves two bus routes, the 65 and 60. Combined average weekday boardings total 49.3, which nearly meets the MBTA threshold of 50 for bench placement. Public housing is nearby, and there is room for a bench along the property wall. A guide wire running from the utility pole to the sidewalk parallel to the curb at this stop restricts access and poses a serious trip hazard.

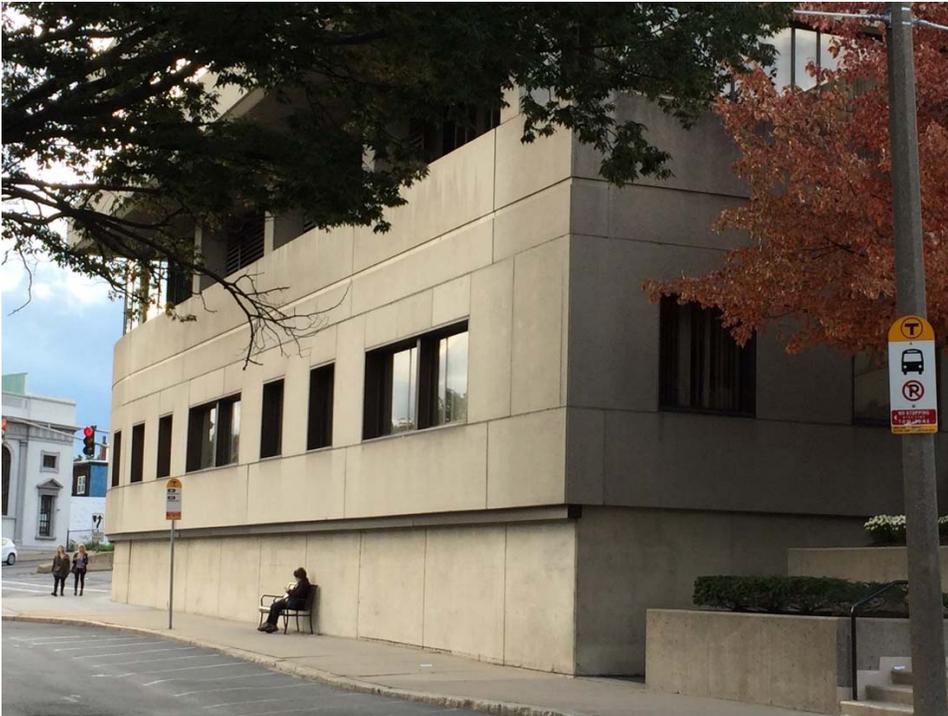
This stop serves two bus routes, the 65 and 66. Combined average weekday boardings total 200.5. This stop serves as a transfer point between the Routes 65 and 66, and the D branch of the Green Line, enhancing eligibility. One bench is present, under an elevated, shallow building overhang that offers little protection. Two standard-size shelters, one large shelter, or (at minimum) one bench plus one standard-size shelter are recommended. Plenty of room is available on the sidewalk for these amenities, which should be chosen & installed in coordination with Gateway East project.

1526, Washington St @ Pearl St: Front bus stop sign is missing. Rear sign is present at 10 Brookline Place.
