**Edward Devotion School**  
**MSBA**  
**Preliminary Design Program**

Brookline, Massachusetts

**Volume 4 of 5**

## Edward Devotion School Concept Study

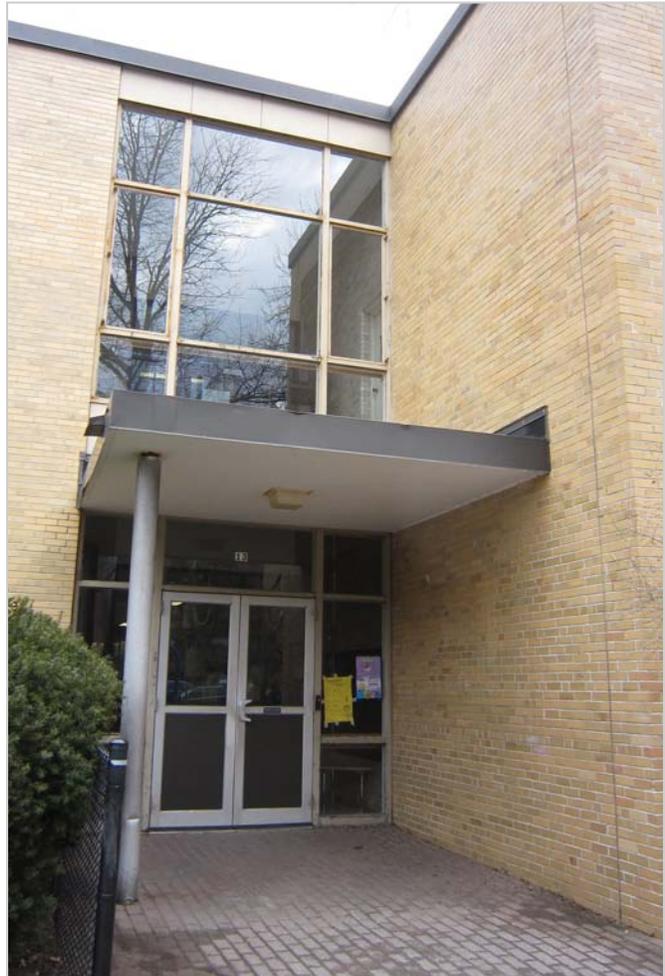
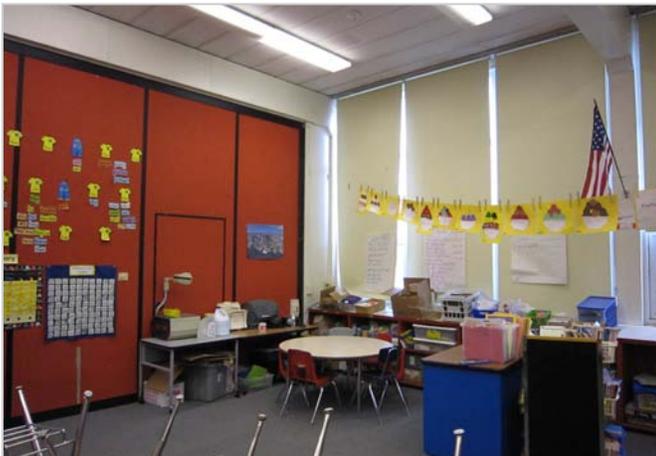
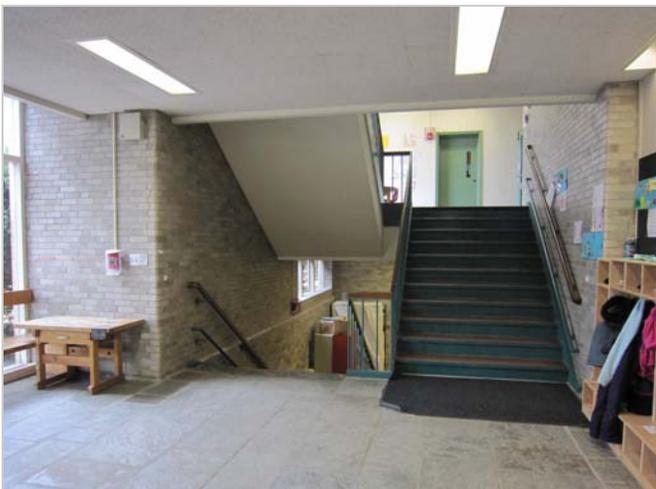
**clockwise**  
Main entrance off loop road,  
Main stair, Typical classroom,  
Exterior facade

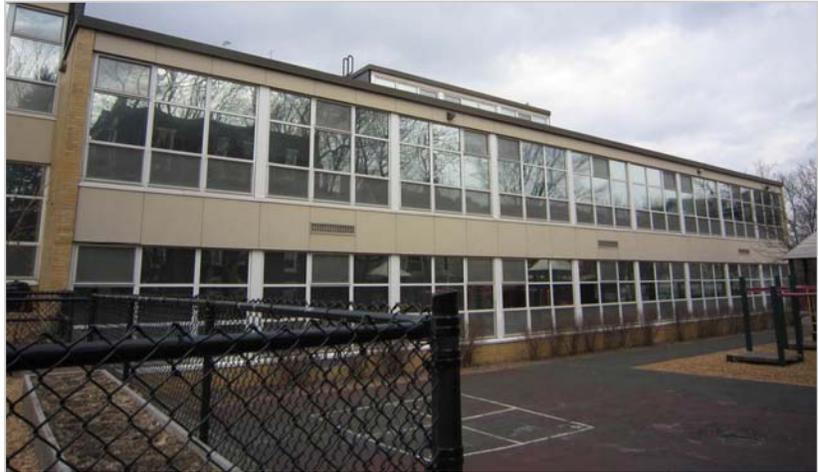
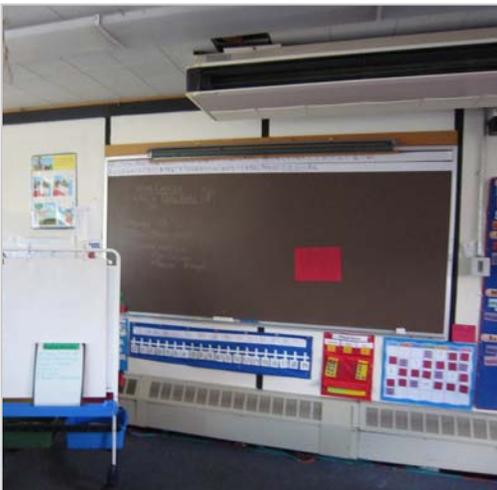
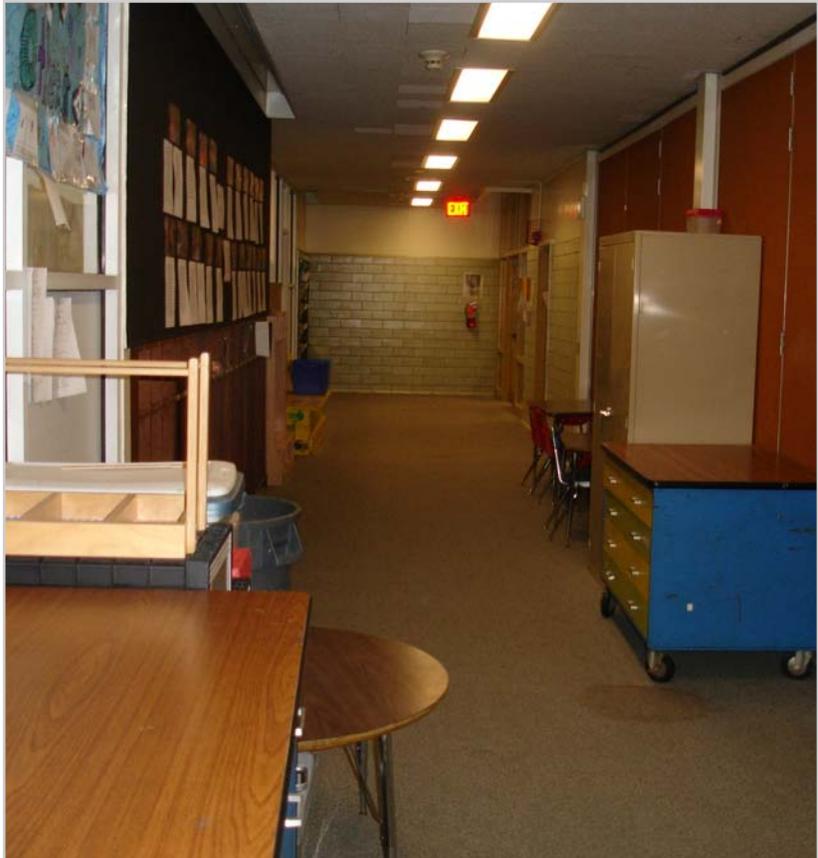
The overall brick masonry structure appears to be in good condition. There are no signs of significant settlement or stress on the building. Some brick veneer areas will require repointing or repair where the veneer has spalled.

**clockwise**  
Exterior facade, Basement  
corridor, Playground,  
"Moveable" partition with  
fixed tiems

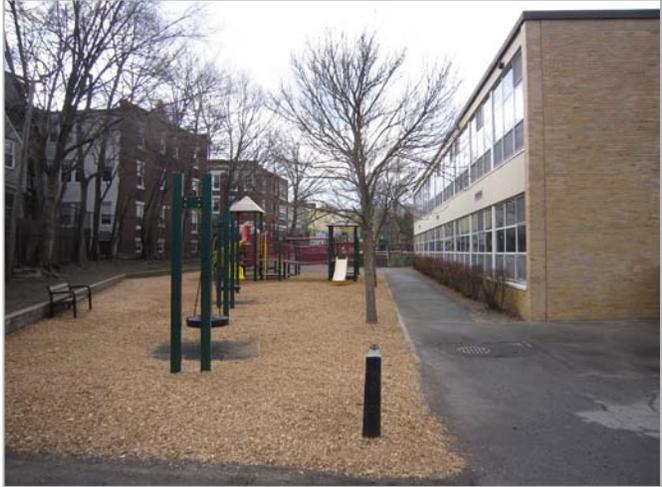
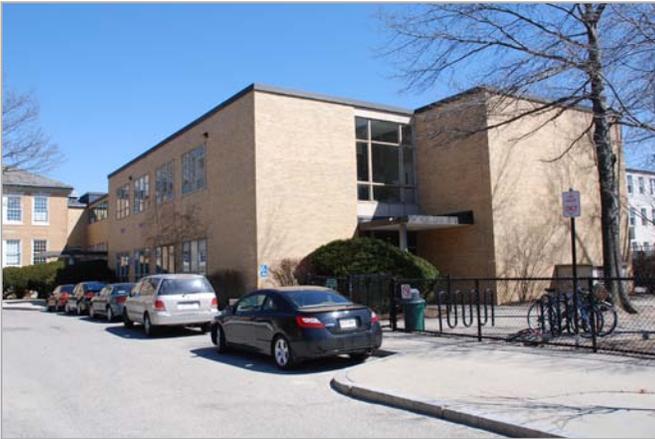
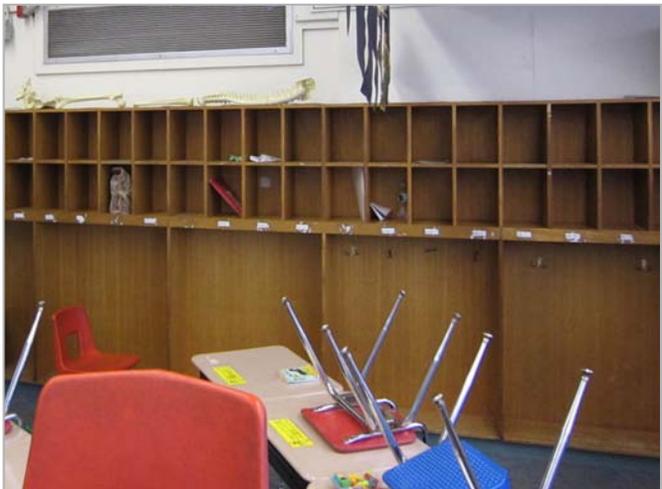
**clockwise**  
Playground, Typical classroom  
cubbies, Main gym interior,  
Exterior of gym, View from  
Harvard Street

The exterior of the gymnasium is showing significant signs of rust. Because this can indicate possible deterioration in the window system, the flashing and drip edges of the system would need to be evaluated for replacement.

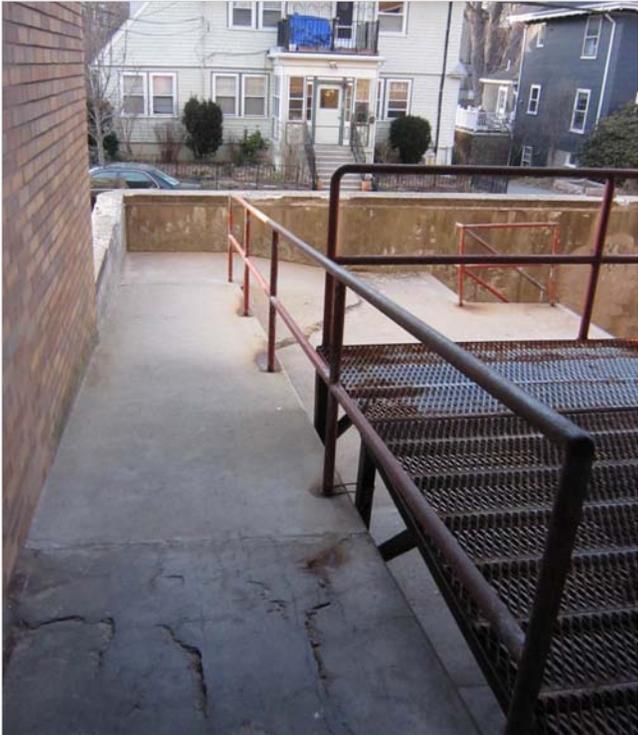
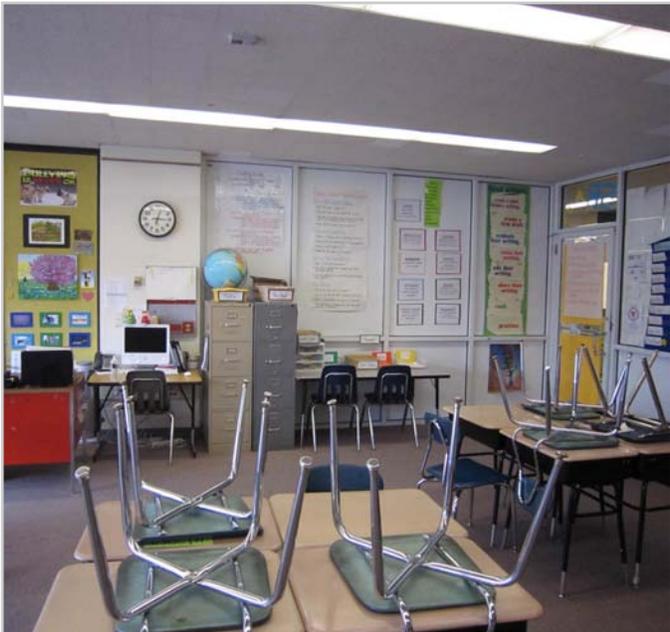
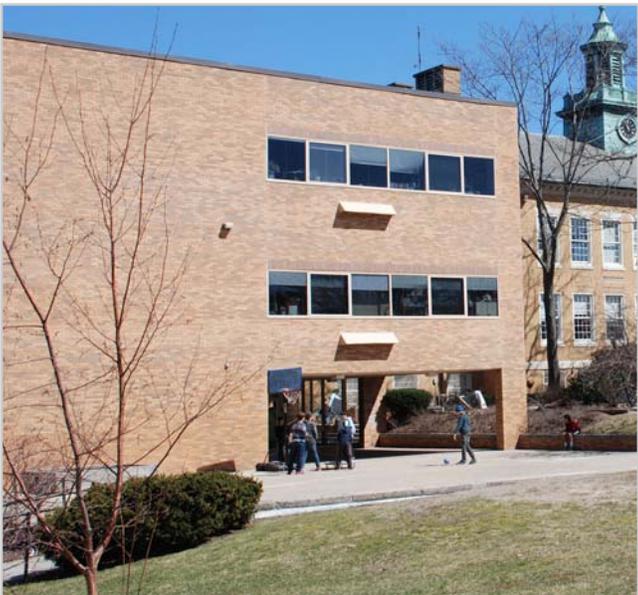
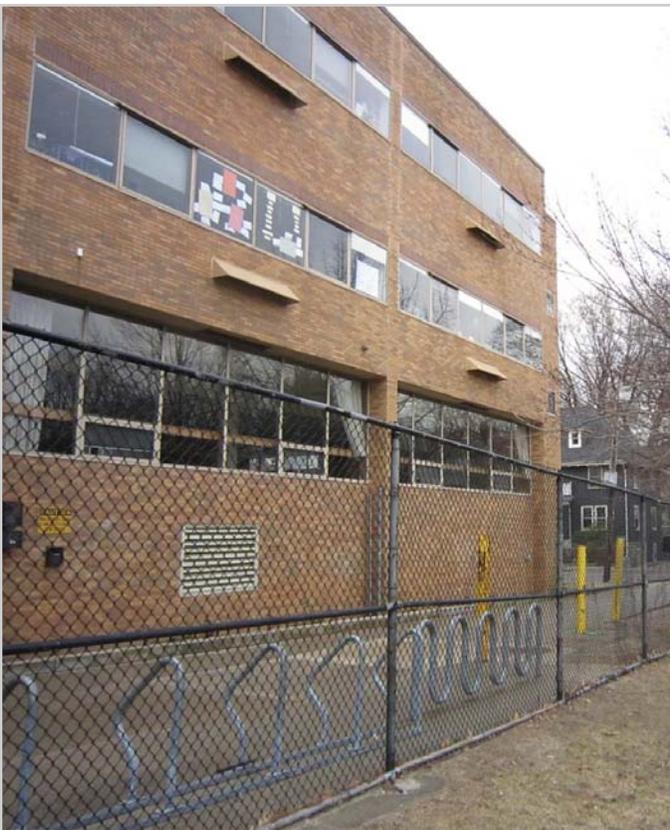
**clockwise**  
Typical classroom, Rear  
facade of 1974 bldg, Harvard St  
plaza deck, Loading dock

The condition of the exterior brick veneer is in fair condition over most of the structure. Some exterior surfaces, including the area around the loading dock, will require localized repointing of the masonry. The flashing around the exterior hoods for the HVAC system at each classroom bay will need to be evaluated, as there is evidence of water entering into the system through this area which may be the result of deteriorated flashing around the hoods.

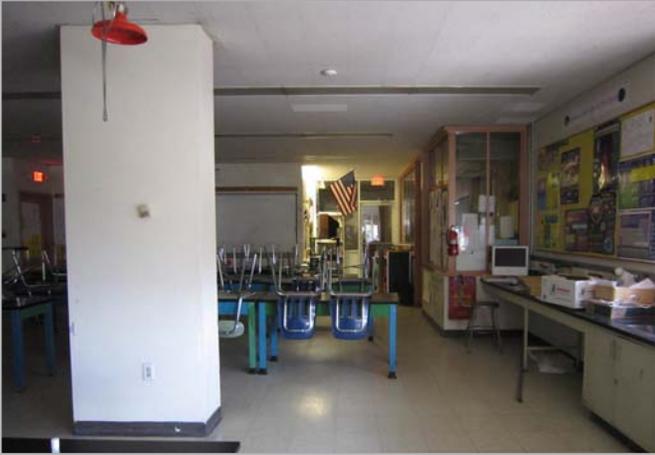
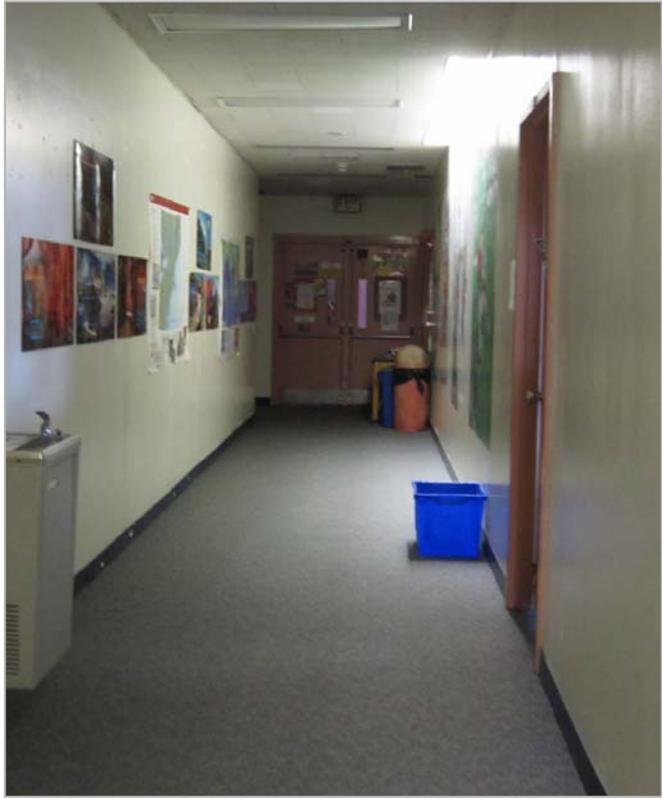
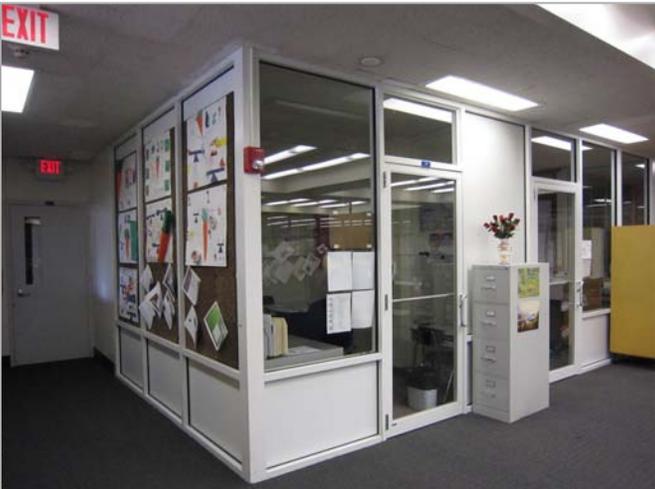
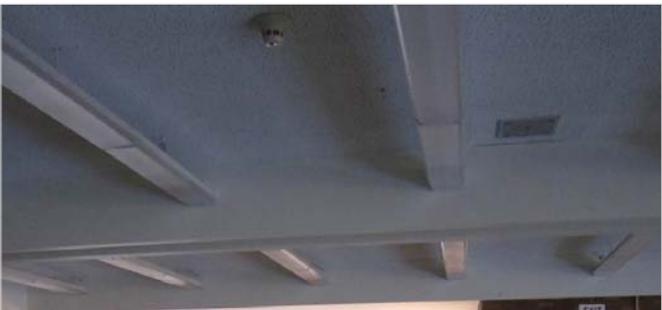
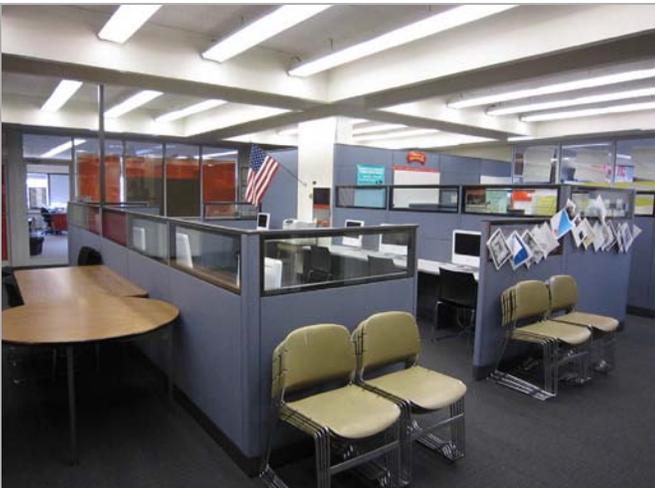
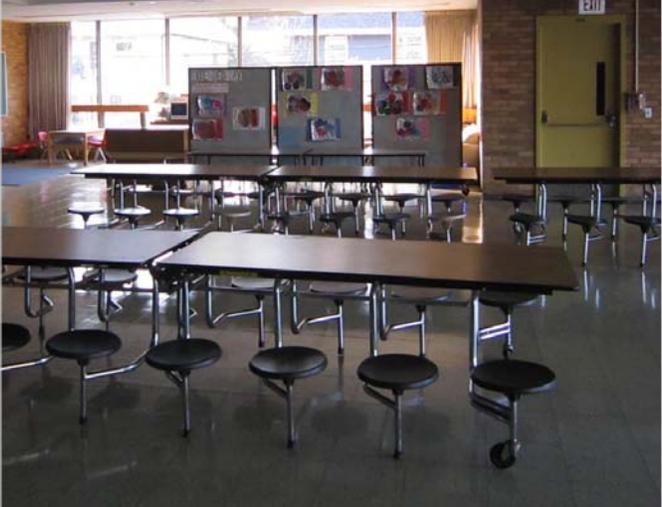
**clockwise**  
Interior corridor, Cafeteria,  
Media area, Interior small  
classroom, Science lab

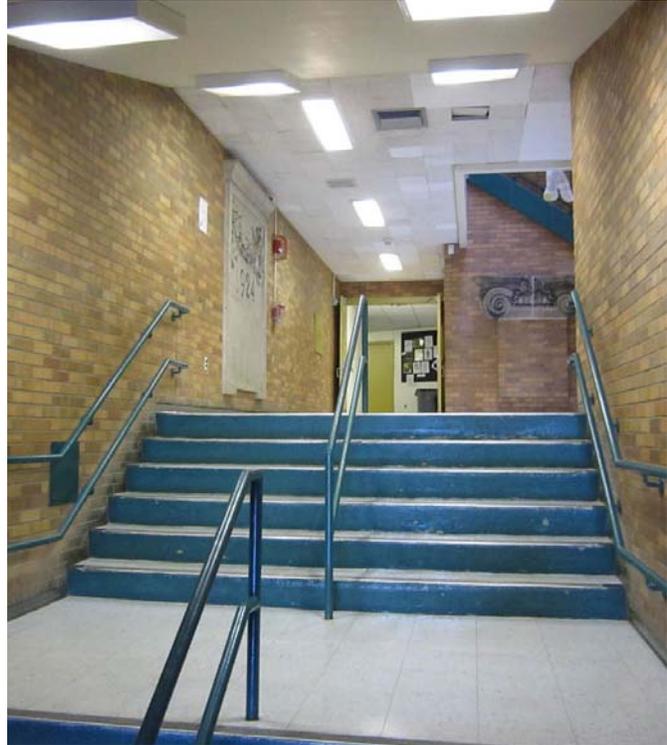
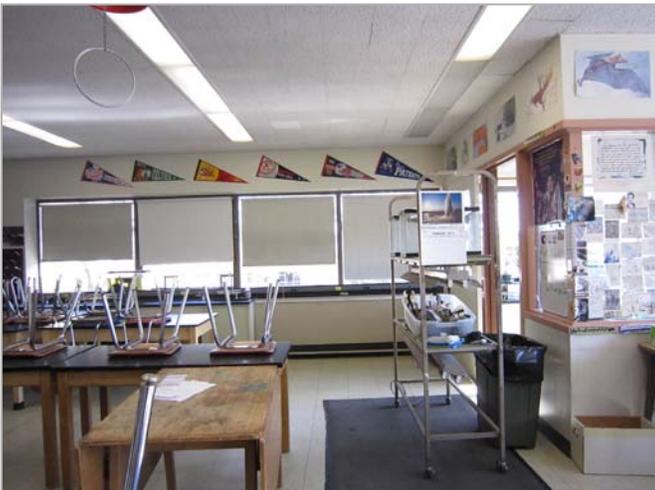
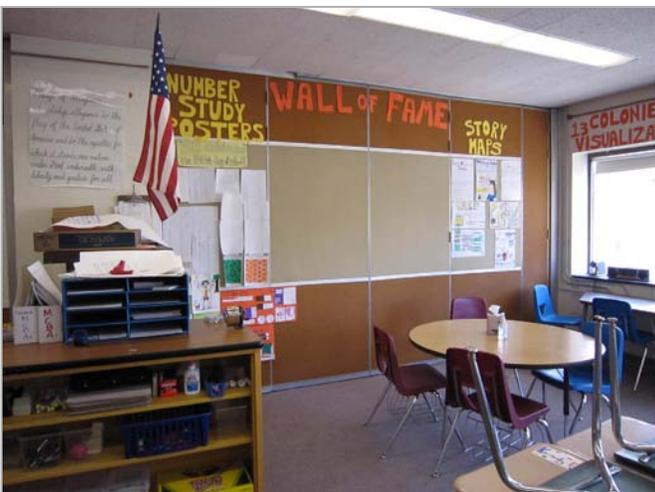
The curtainwall has been installed to separate the classrooms from the interior corridors. Separations between classrooms are typically the original moveable panel partitions, now permanently in the closed position. As noted with the 1954 building existing conditions, operable partitions provide poor acoustic separation due to the lack of sealants around the paneling to completely seal off one space from the other. The interior curtainwall system would also be inferior in acoustic separation to a typical classroom wall construction due to its single layer of glazing construction.

**clockwise**  
Inaccessible rear stair  
entrance, Main stairwell,  
Classroom "moveable"  
partition, Classroom

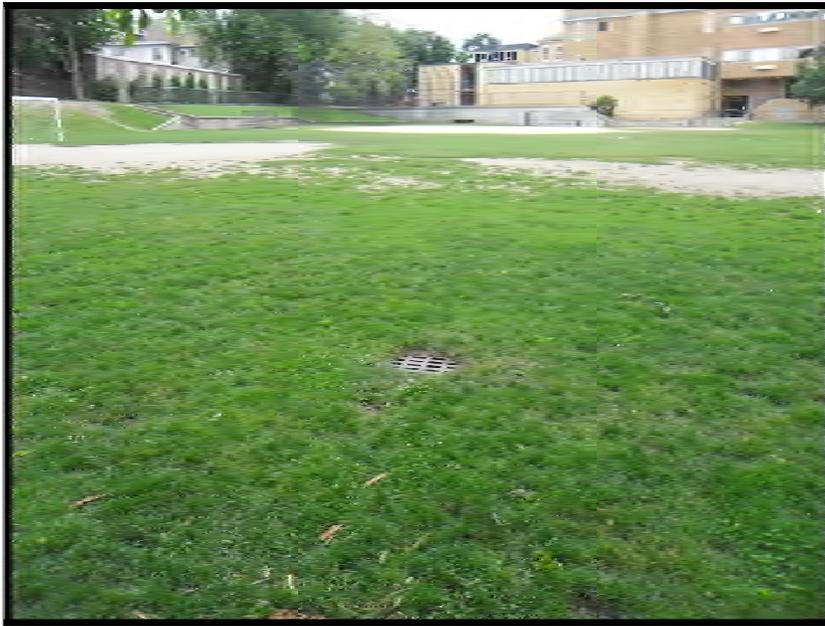
Nobis observed four catch basins in the northwestern portion of the ball field; one in the grass in the north central portion of the ball field, one adjacent to the paved walkway near the northwestern corner of the ball field, and two in the grass near the northwestern corner of the ball field (see Brookline Site Plan for locations). These catch basins were approximately five feet deep, appeared to be of older construction, and all but one contained a significant amount of debris. It was unclear based on visual inspection if any drainage piping entered these catch basins, or if they merely acted as dry wells.

Photo 1 – Catch Basin in Northern Portion of Ball Field, Looking South

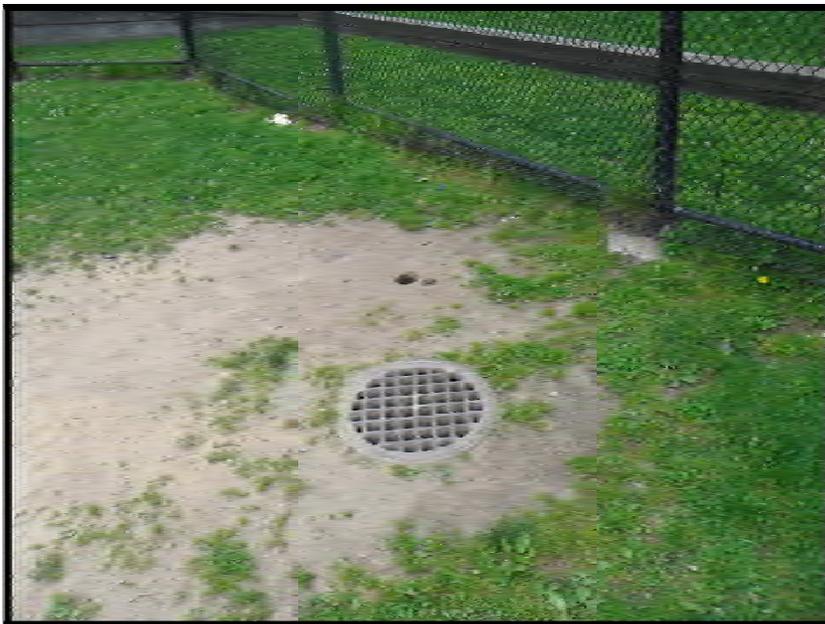
Nobis observed three catch basins in the southeastern portion of the ball field; one near each player bench and one behind home plate. These catch basins were cleaner than those in the northwestern portion of the ball field, and appeared to be of newer construction. The Brookline Site Plan depicts the catch basin behind home plate as being connected to the manhole in the north central portion of the ball field, and to the manhole in the southern basketball courts by a 10" drain line. The plan does not show the two catch basins near the player benches, and no pipes were visible in either of these two catch basins. They likely act as dry wells, but this should be confirmed through further visual inspection of the inside of the basins. School maintenance staff did not indicate that flooding was an issue in this portion of the property.

Photo 2 – Catch Basin Behind Home Plate in Ball Field

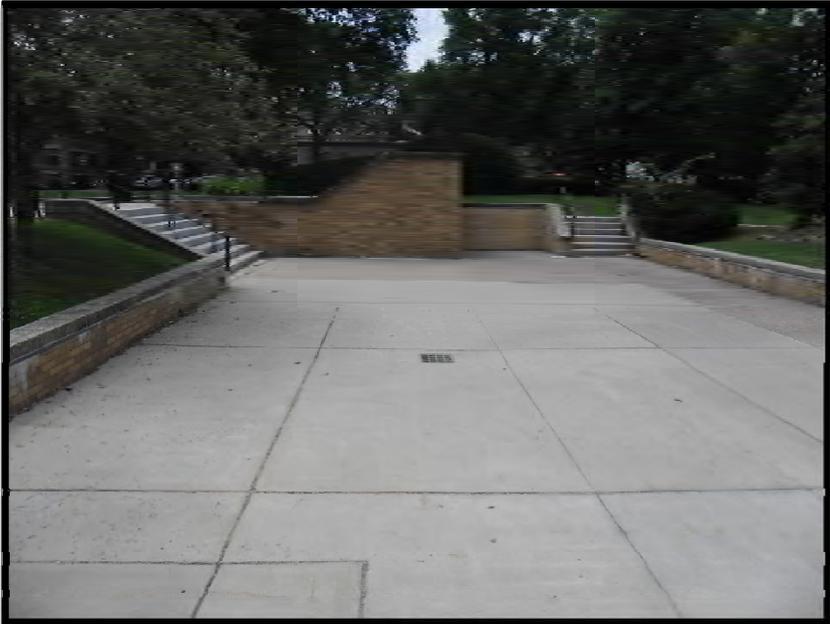
Nobis observed six small rectangular drains in the southwestern front patio area. School maintenance staff believed that these drains were connected to the town drain line on Stedman Street, but none of the drains appeared on the Site Plans or GIS Figure, so this could not be confirmed. School maintenance staff indicated that minor flooding occurs frequently in this area (approximately 1-2 inches of standing water) during rain events.

Photo 3 – Southwestern Front Patio, Looking South.

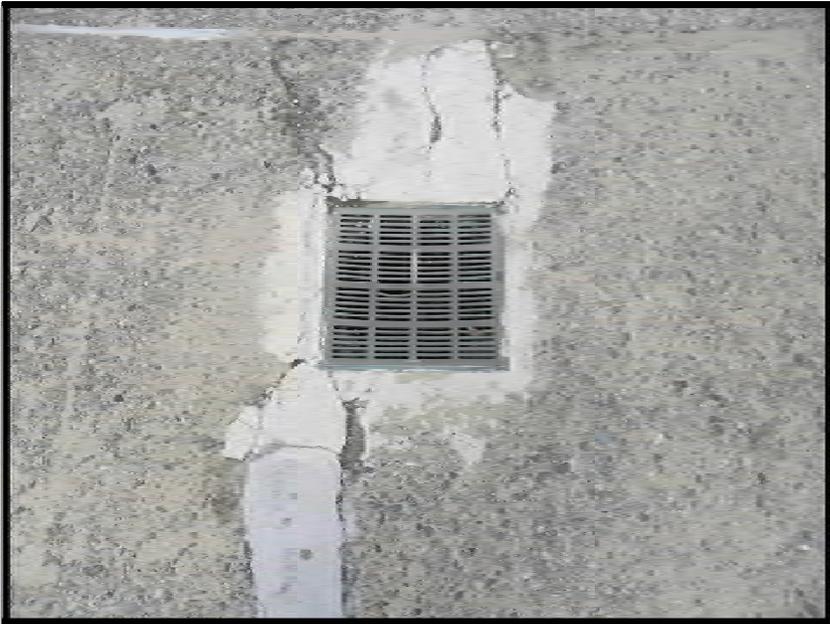
Photo 4 – Drain in Southwestern Front Patio

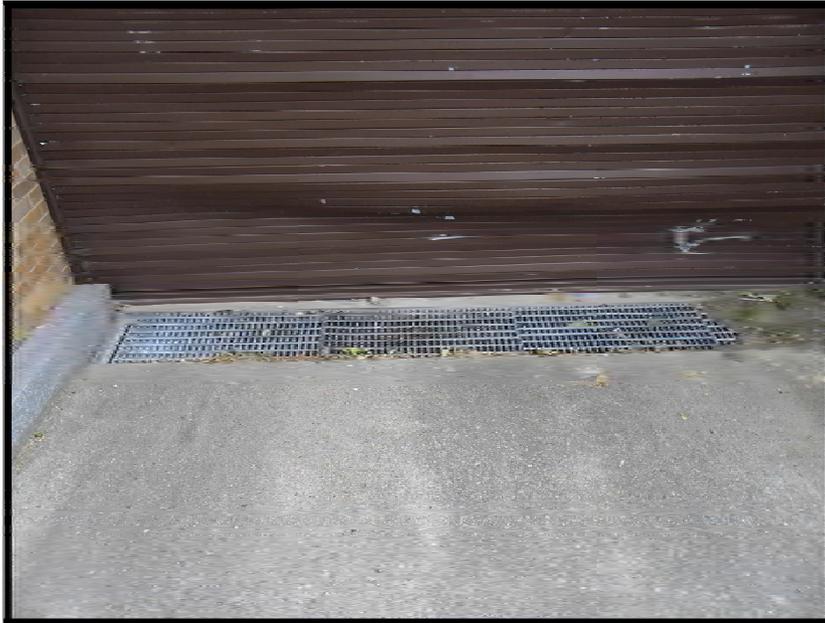
On the western side of the building along Stedman Street there are two driveways which slope down to the garage areas on the first floor of the building. In between the two driveways there is a set of concrete stairs which lead up to the second floor of the building. Nobis observed long rectangular grate drains at each of the two driveways. School maintenance staff indicated that these grate drains are in good working condition, and flooding is not an issue at these areas. The Brookline Drainage Plan appears to depict a drain line near the northern driveway connecting to the Stedman Street drain line, indicating that one or both of these grate drains are connected to the municipal drainage system.

Photo 5 – Grate Drain in Western Driveway

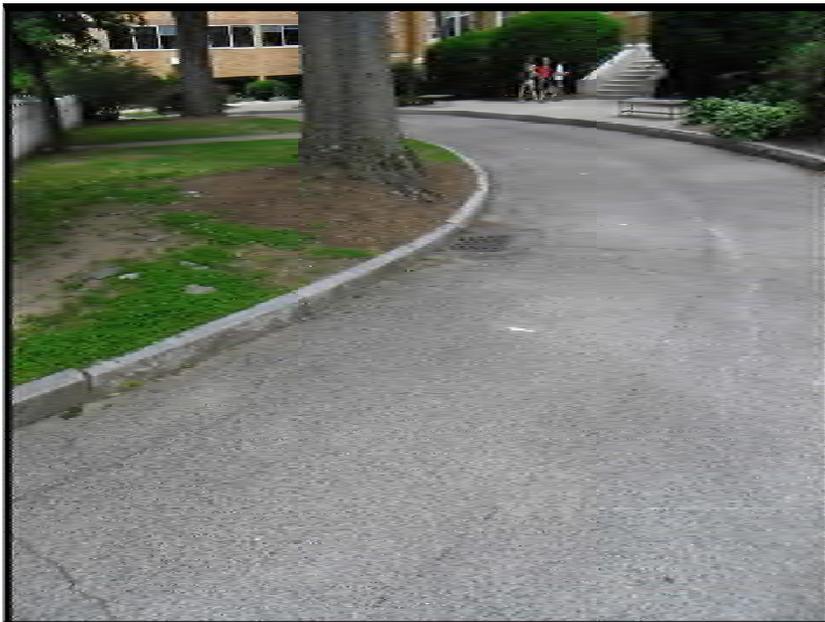
The front of the Site contains a lawn with an entrance drive, as well as a small historic building. This area is separated from the southwestern front patio (described below) by an approximately three foot high retaining wall. Nobis observed three catch basins in the driveway, each of which appeared to drain to Harvard Street. GIS plans obtained from the Town of Brookline appear to show five catch basins in the general area of the front driveway. School maintenance staff did not indicate that flooding is an issue in this portion of the Site.

Photo 6 – Catch Basin in Front Driveway, Looking North

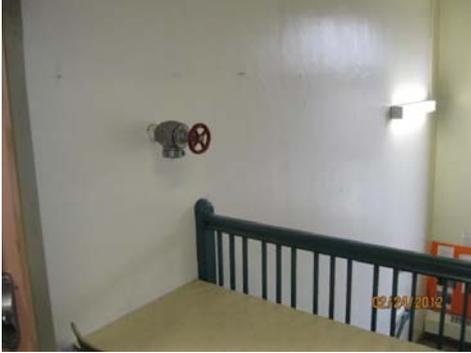
Class 1 standpipes are located in the main stair off of the cafeteria and hose valves are located in other interior stairs off of the original wing.

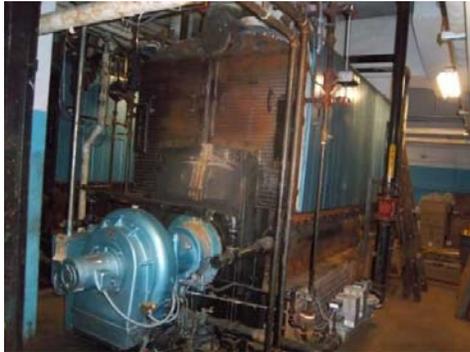
The three wings of the Devotion School (1910, 1954 and 1974) are served by a central boiler plant located in the 1910 wing. Two 7,500 MBH input sectional cast iron steam boilers with dual fuel burners were installed in 1992. The low pressure steam (LPS) boilers feed the garage, steam absorption chiller, steam to hot water (HW) shell and tube heat exchangers, unit ventilators in the 1954 wing and AC-1 and 2.

A 325 ton steam absorption chiller and 325 ton cooling tower were installed during the 1974 addition. The chiller is located adjacent to the parking garage, and cooling tower is located on the roof of the 1974 addition. The chiller was operated for one year and has not been used since according to the school's facilities staff.

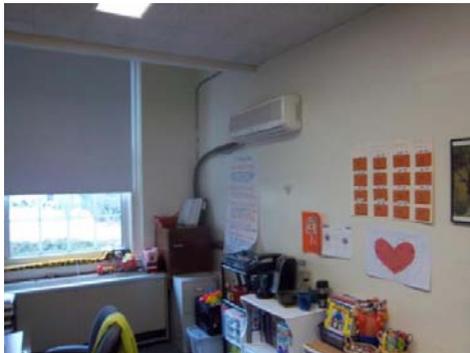
LPS currently serves the steam coils in the garage, heat exchangers in the boiler plant, unit ventilators in the 1954 wing and the AC-2 steam heating coil in the mechanical penthouse. In addition to the chiller, the AC-1 and 2 humidifiers are no longer operated either. The HW side of the heat exchangers have three pumps with three distribution loops for: duct mounted reheat coils, fin tube radiation (FTR) and cabinet unit heaters (CUH), and unit ventilators (UV). The chiller and AC-1 and 2 humidifiers are no longer operated.

The UV pipe loop was designed as a two pipe changeover system for heating and cooling, and the heating and cooling are isolated with valving. This loop is tied into the chiller but has not been used for cooling because the chiller is not operated. Within the past fifteen years, supplemental cooling to the following rooms:

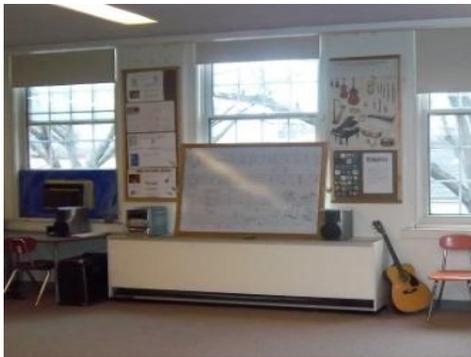
Air handlers, AC-1 and 2, located in the mechanical penthouse of the 1974 Addition provide heating and ventilation air to interior spaces in the 1910 and 1974 wings, Library and Auditorium/Multi-purpose room. An air handling unit also serves the main gymnasium.

The Cafeteria, Classrooms and perimeter offices are served by unit ventilators. The unit ventilators in the 1910 and 1974 wings have hydronic coils, and those in the 1954 wing have the original steam coils. Perimeter rooms also have hydronic or steam fin tube radiation.

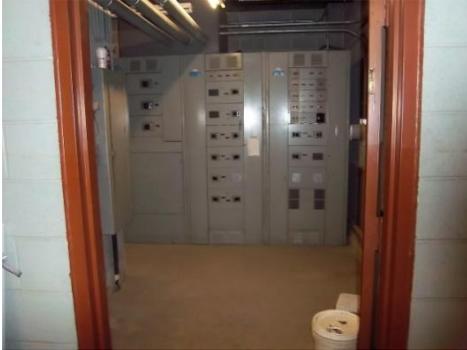
All three wings of the building are served by a 3000 Amp, 208Y/120V, 3-phase, 4-wire Main Switchboard located in the Main Electrical Room in the basement of the 1974 wing. The switchboard was manufactured by ITE, and the nameplate date is 1975. The switchboard appears to be in good condition, but there is no evidence that circuit breakers are tested. Testing provides confidence that breakers will trip if required. Replacement breakers are difficult to find so replacement of the switchboard is recommended but not absolutely necessary. This would require an interruption of service of up to one week.

Replacement would be recommended over the summer when school is not in session or during winter break.

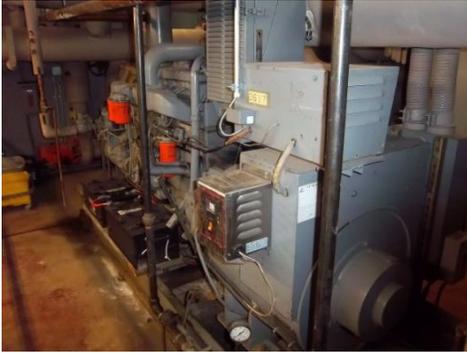
A 175kW (continuous rating) diesel generator provides backup power to the entire school through one transfer switch. The generator appears to be in good condition and well maintained. The generator was installed during the 1974 project, and replacement parts are difficult to find. The generator and transfer switch are located in the Mechanical Equipment Room basement of the 1974 wing. The transfer switch feeds one Emergency Distribution Panel "E-D". Panel E-D feeds nine smaller panelboards located throughout the school.

The emergency panel boards do not appear to be enclosed in the required 2-hour fire-rated enclosure.

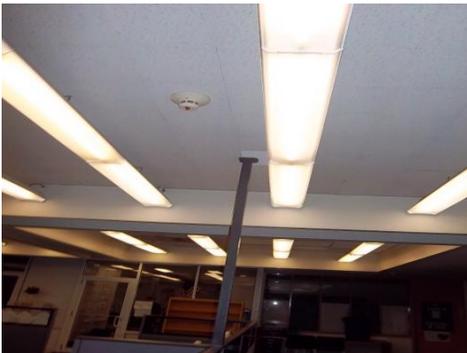
Much of the fluorescent lighting is old and likely installed before 1979. Lenses have typically yellowed throughout. Replacement of the existing lighting is recommended, and fluorescent lighting ballasts installed before 1979 may contain PCB's.

No lighting control system was found. A lighting control system for the entire building is recommended for compliance with current energy codes.

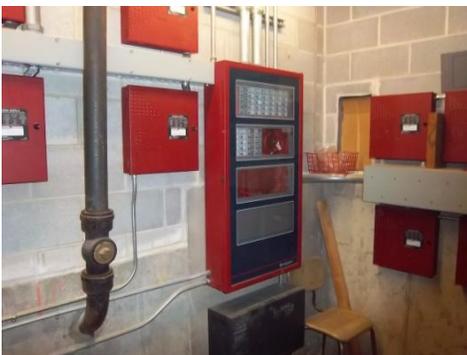
The Fire Alarm system serving the school was installed during an upgrade project in 2000 and appears to be in excellent condition. The Fire Alarm Control Panel (FACP) is located in the Electrical Equipment Room in the basement of the 1974 wing. Re-use of the existing system may be possible. Further investigation is required to determine if parts are still available and whether the system meets present code requirements.
